Effect of the Chemical Composition of Building Materials on Algal Biofouling

Philippe Grosseau, Estelle Dalod, Alexandre Govin, Christine Lors, René Guyonnet, Denis Damidot

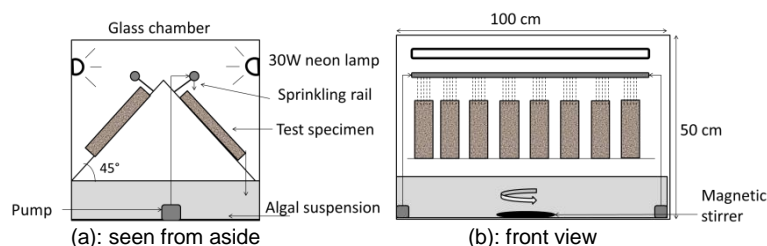
The system consisted of a glass chamber of dimensions 100x50x50 cm in which were settled two stainless steel supports inclined at 45 ° (Figure 1). The mortar samples were exposed to the same conditions of light ($20\mu\text{mol}/\text{m}^2/\text{s}$ PPF, photoperiods of 12 hours) and temperature (20°C) as for the algal growth. The temperature was maintained with a thermoregulator. The box was filled with 50L of microalgal suspension, (concentration of 4mg/L dry mass) which was pumped and sprinkled on the top of mortar samples. The watering was made by means of a full holes banister of 2 mm in diameter, every 1 cm. The flow was set to 26 ± 1 L/h. The sprinkling was carried out for 90 minutes every 12 hours and enabled to reproduce the phenomenon of colonization of a facade: microalgae were transported by the solution and had the possibility of hanging on and of adhering to the surface according to the characteristics of the mortar.

Figure 1. Laboratory bench for the colonization of mortars by streaming of algal suspension

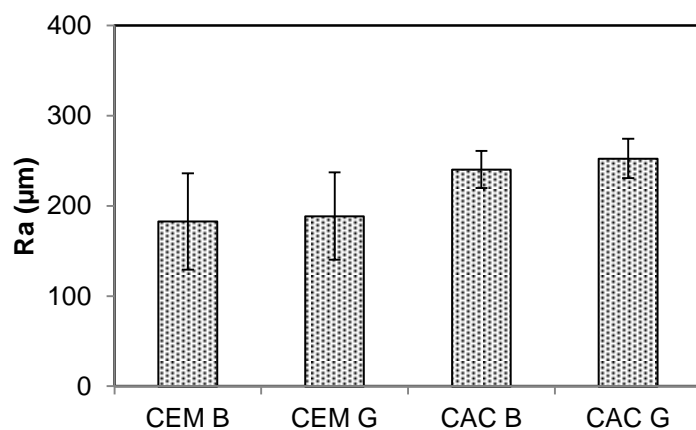
Figure 4. Roughness of studied materials

Results represented on Figures 4, 5 and 6 show that roughness, surface pH and porosity are not significantly different for all samples, around a value of about $220\ \mu\text{m}$ for roughness, 8.8 for surface pH and 14% for the porosity. This is an important result since it was already proven that these characteristics have a strong influence on the kinetics of biocolonization of mortars (4,5,9,12,13,14). As the physical characteristics of presently studied mortars are similar, we will thus be able to compare the effect of the chemical composition on the resistance to biofouling.

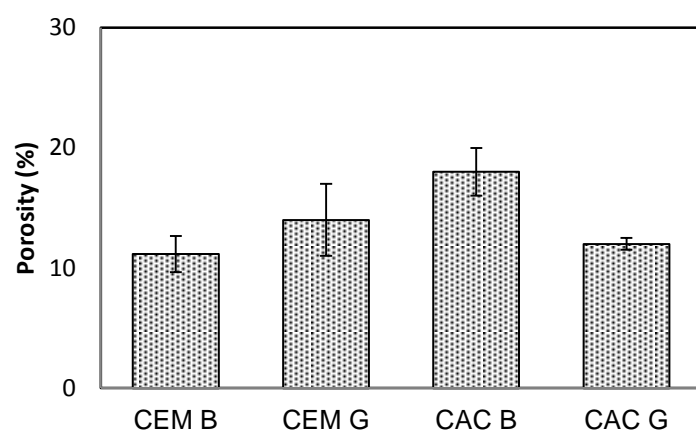
Figure 5. Porosities of studied materials

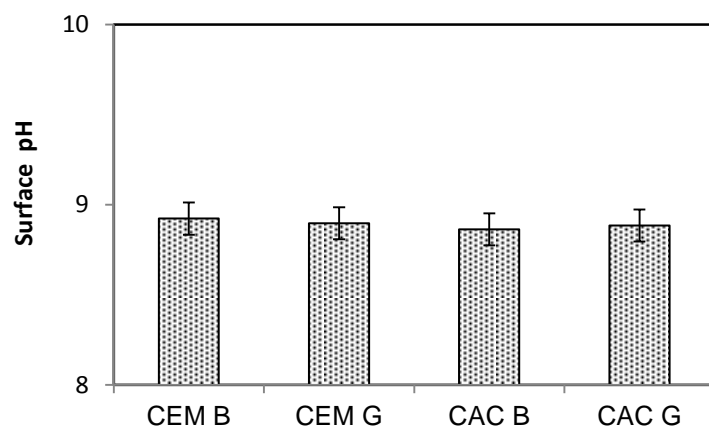
Figure 6. Surface pH of studied materials

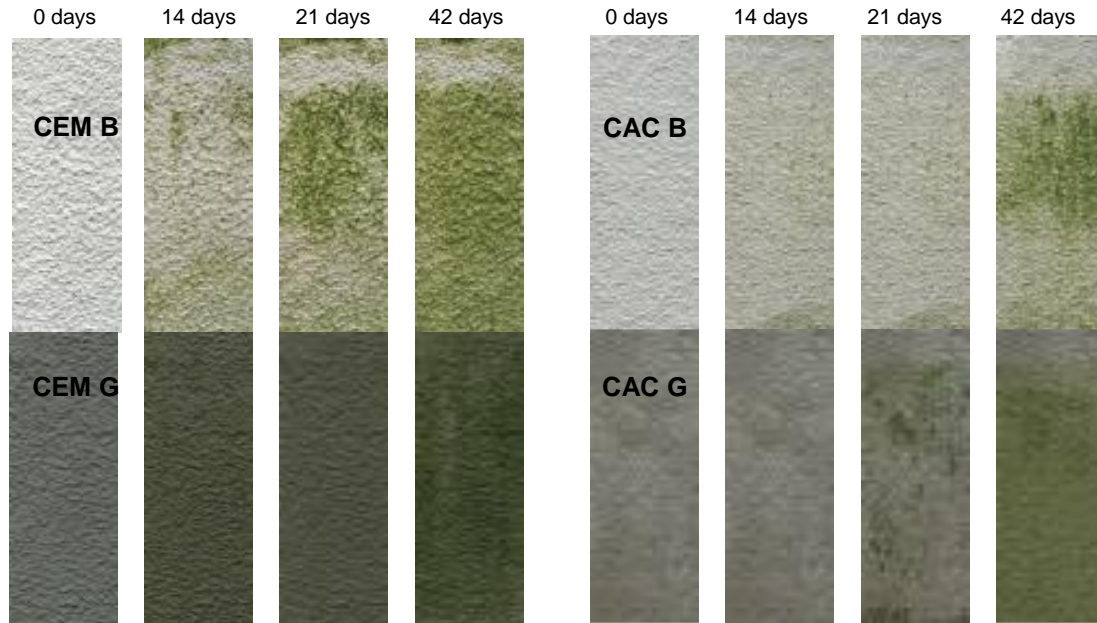
The pictures of Figure 7 show the evolution of the surface of the specimens during the test period for Portland cement mortars and CAC mortars and we can thus notice that CAC based mortars were much less quickly colonized than Portland cement based mortars.

Figure 7. Evolution of the biocolonisation of the samples during accelerated laboratory test

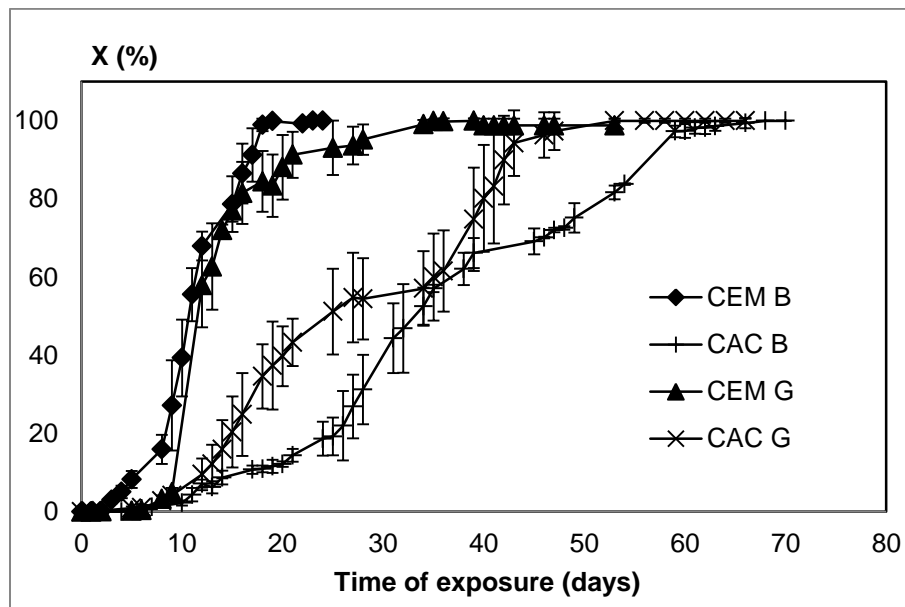
This phenomenon is fully confirmed by the evolution of the colonization rates of the specimens which is shown on Figure 8. The colonization of Portland cement based mortars both started earlier and was completed in a shorter time than the colonization of CAC based mortars.

Figure 8. Evolution of the fraction of colonized area during accelerated laboratory test

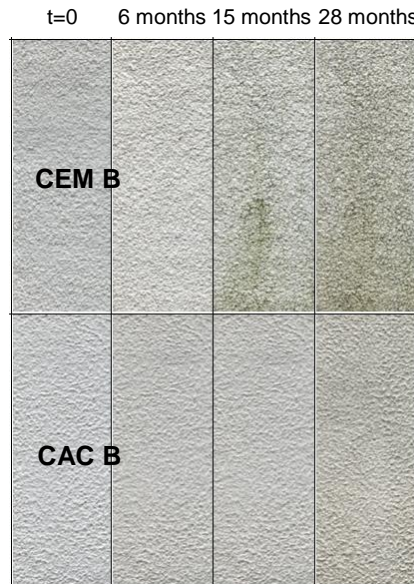
Figure 9. Evolution of the biocolonisation of the samples during outdoor exposition

This part of the work was realised only with white mortars CEM B and CAC B. The samples were exposed from March 2012, at the beginning of spring. In a similar manner to what happened in laboratory tests, we can again notice that mortars containing CAC cement were more slowly colonized than the mortars which contain Portland cement (Figures 9 and 10).

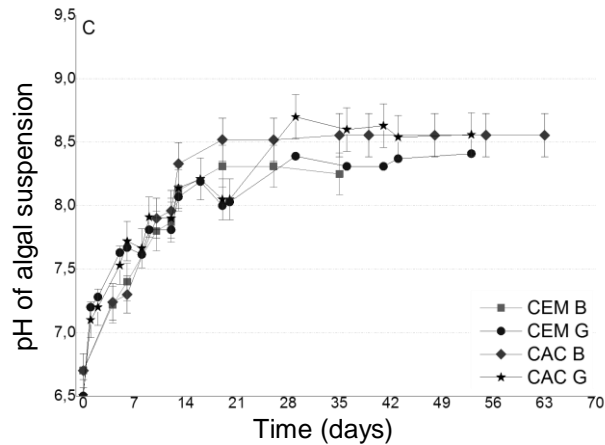
Figure 12. Evolution of the pH of algal suspension during laboratory test

In order to verify that the observed phenomena were not due to a difference in the alkalinity of the studied mortars, we followed the evolution of surface pH of the samples and of the pH of the algal suspension all along the laboratory test. The results are shown in Figures 11 and 12. It is quite clear that there are no significant differences between the different materials tested, which is of course consistent with the fact that all samples are carbonated.
